LAPP, the 21th of May 2002.

Abstract:

*This note reviews the inspection of the **ECAL engineering model** performed at LAPP the 15th of May 2002 on delivery of it, with the presence of representatives of IHEP (Beijing). This detector was shipped from Beijing to CERN at the end of April 2002, and then moved to LAPP.*

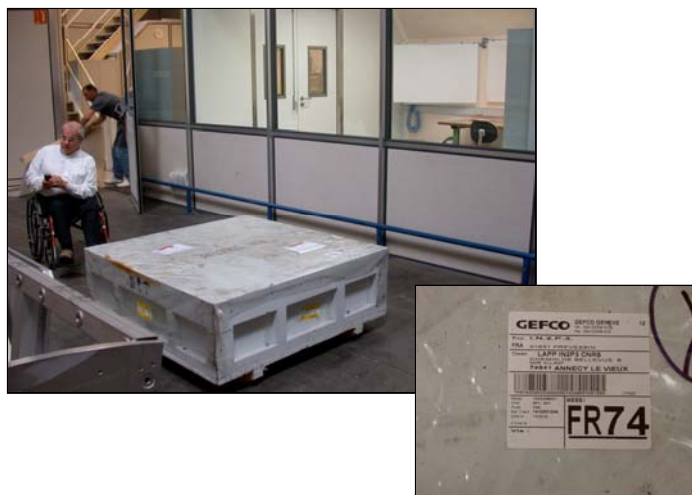
The ECAL in its
Packaging for
transportation

The box was opened carefully and a visual inspection was made before any handling. Several set of scratches are observed on the cover plate of honeycomb, though being superficial. On the sides, the

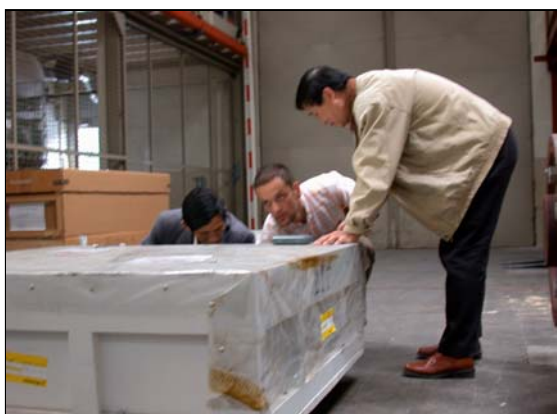
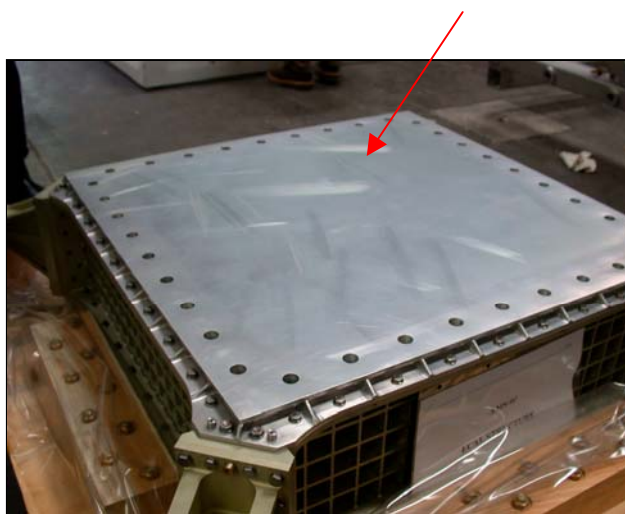
From the inspection of the holes for PMT's on the lateral panels, it appears that the spring foam is not properly positioned on the inner bars the lateral panel, so that many holes are partly obstructed (by about 1 mm) by the spring foam. It is therefore clear that the go-nogo gauge test shown in a transparency at the TIM meeting in may has been performed before mounting the spring foam and assembling the structure with the pancake. It will be necessary in the future to make the test in the right way, when the support structure is closed with the pancake in it.

Due to this default, it will be necessary to push the spring foam off the holes with a special tool before mounting the PMT tubes.

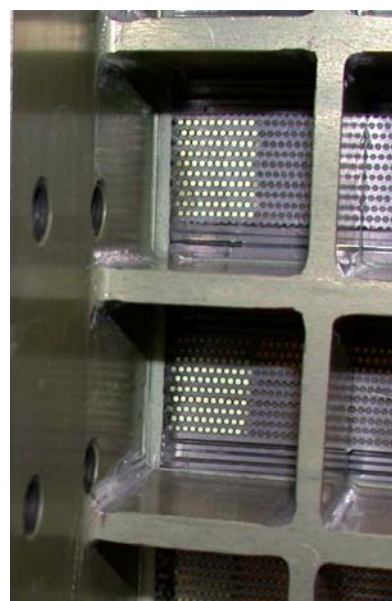
From the careful inspection of the ECAL it seems that there is some damage on an edge the pancake.

The picture on the right shows that some fibres on the edge are either missing or damaged. This was not observed previously. Though it is not possible today to identify the origin of the problem, it is clear that special care should be taken while inserting the pancake in the mechanical support structure to avoid such problem.

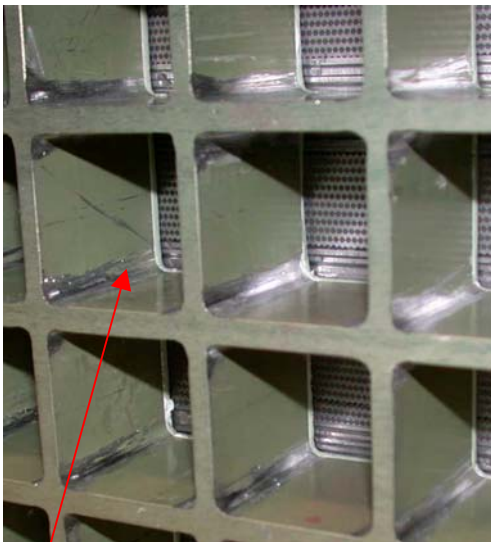
Spring foam overrun

Spring foam position: as mentioned in the section on visual inspection, the spring foam is not correctly positioned on the lateral panel in some of the PMT holes. The **centring defect** was measured to be between 0.5 mm and 1 mm in some holes) which need to be fixed before mounting the light collection system.

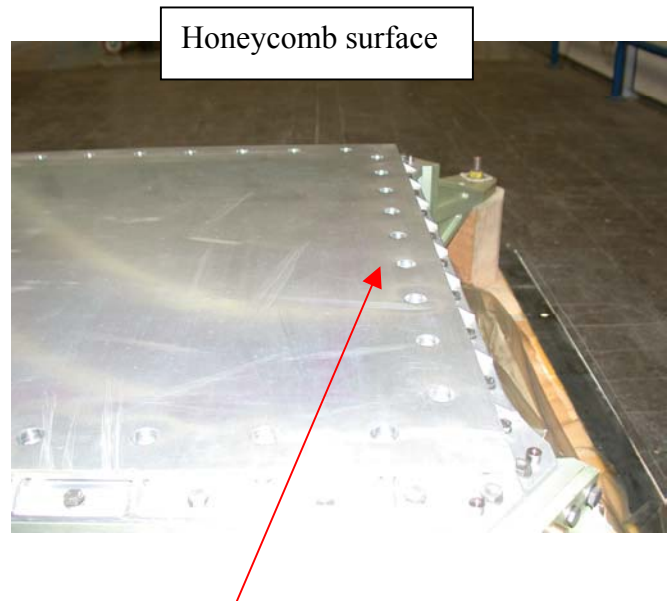
no important central deflection occurred (less than 0.2 mm). The only small deflection is near the connexion (gluing) with its aluminium frame.

Small deflection at the frame interface with the aluminium foil

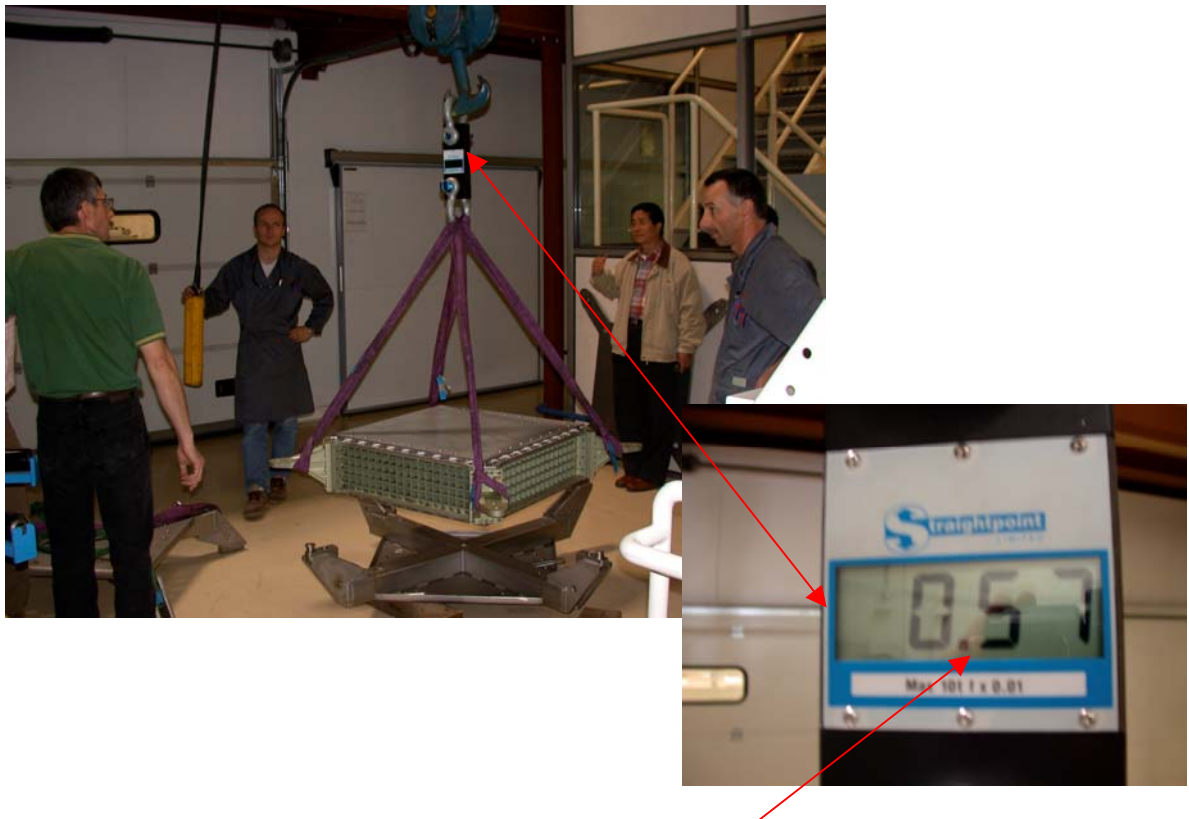
Display in ton

The Ecal weight including supporting structure (Lateral panels, brackets, honeycombs, bolts, screws, shearing pins, spring foams) and pancake has been measured by using a weighing machine displaying the result in tons. According to the oscillation between 560 Kg and 570 Kg a weight close to **565 Kg** can be assumed (to be confirmed by a weighing of each piece)

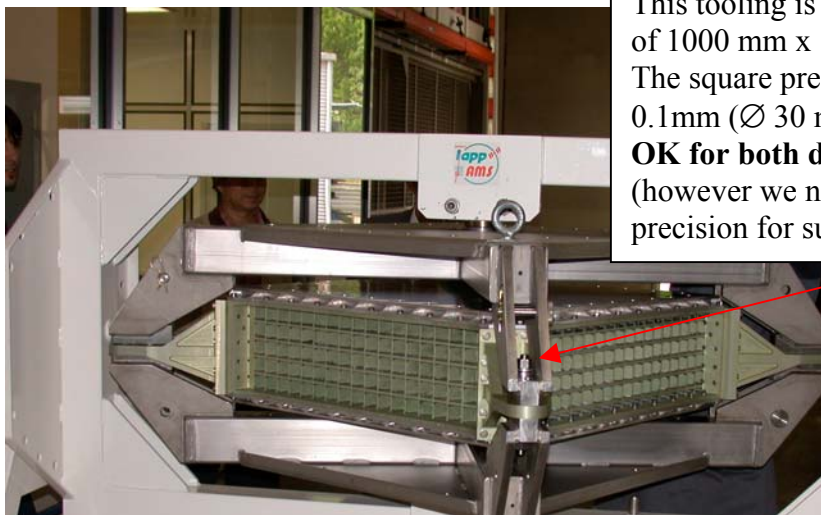
This tooling is also a way to check the square of 1000 mm x 1000 mm (USSII interface). The square precision of the tooling is $\pm 0.1\text{mm}$ ($\varnothing 30\text{ mm}$ for the holes).

OK for both dimensions and flatness.
(however we need to know exactly the USSII precision for such a length).
